Princes Risborough North Signal Box

Newsletter

No. 1 - Summer 2015

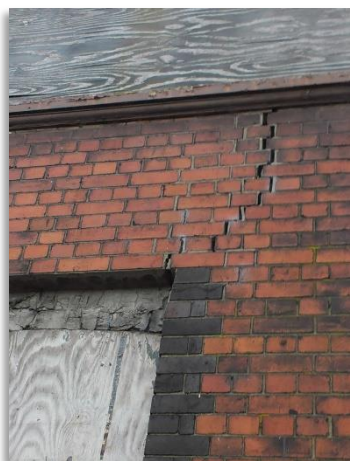
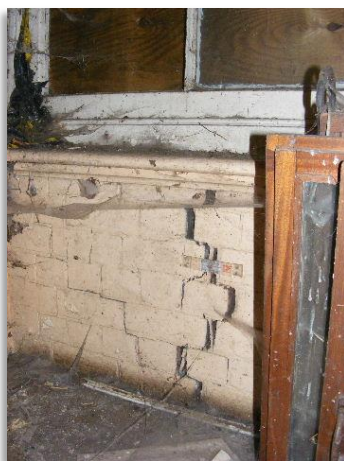
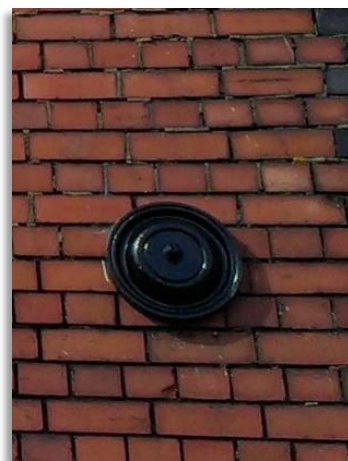
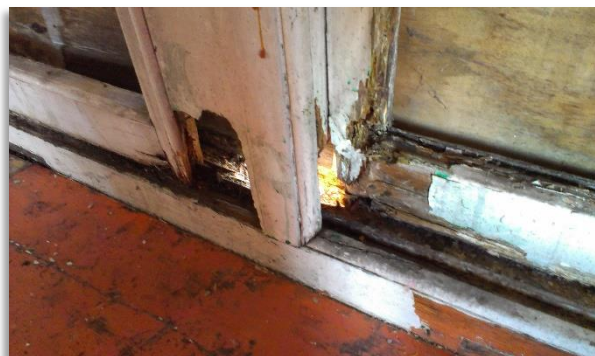
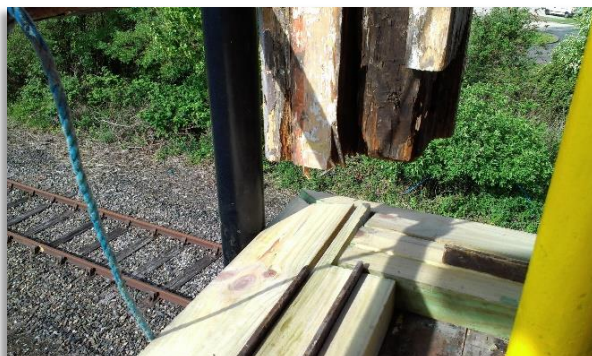
The replacement of each pair of sash windows provides an external image of progress but there is of course a lot more happening that is not so obvious. It's worth noting some of the main structural problems that have been dealt with since we gained access on Oct 2013. One of the more serious was the movement of the north wall as can be seen in these pictures showing it separating from the rest of the building. At the upper window sill level we've recorded about ¾" of movement. This has been halted by the insertion of tie-rods running the complete length of the box with patress plates at either end.

Where support posts and window sills have rotted the dead wood is cut out. New pieces are fabricated and fitted in to match. Once painted looks as good as new and able to take the weight bearing required to keep the structure sound. We've tackled two locations so far with at least another 3 or 4 that we know about to do.

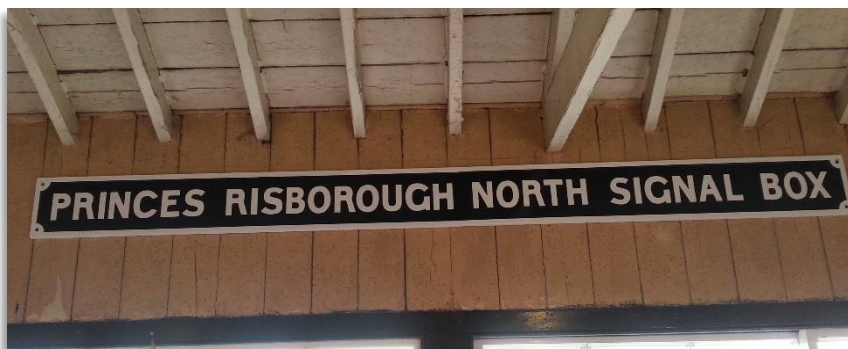
We've had new nameboards cast from aluminium after a collection from a small group of volunteers. Now painted and ready for mounting on the front of the box - see photograph.

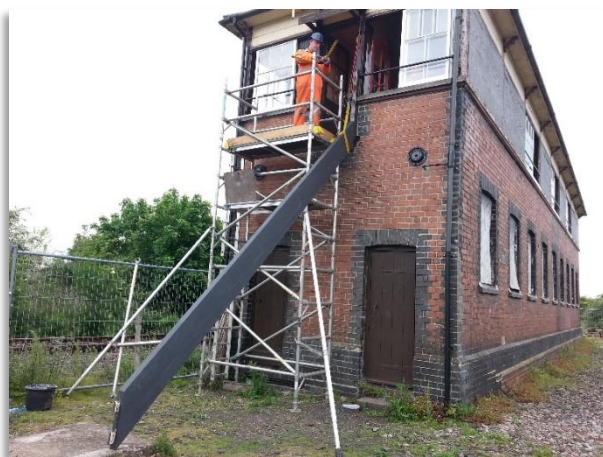
One of the strings and associated parts being made to fit in the downstairs area by Jeff and Richard (left). Richard holding one "old" and one "new" newel post (right).

Design and fabrication of all the pieces required to put back the staircase has been continuing at a pace. The joinery department which repaired many of the sash windows upstairs has moved down to the ground floor where the parts have been cut and machined. The picture to the right shows the right hand string being checked for position for the first time and allowing for adjustments to be made for when it's ready for permanent fixing.

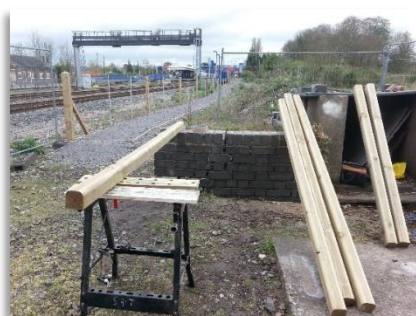
Other pictures showing the hand rails being formed (left). Cut out section on newel post to accommodate the screw and safety bar that resides across each window (right).

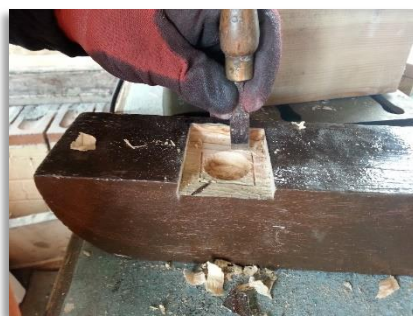
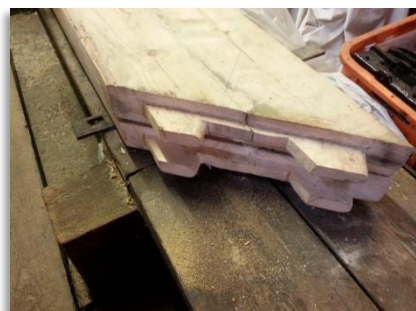
Tenon joints at top of string for fixing to newel post (lower left). Steps being painted (lower right). Fortunately we still have the original tread plates and chairs to hold each step in place.
